From: Gregg Brown
Sent: Monday, June 5, 2017 9:40 AM
To: Trevor Stedke; Landon Nitschke; Jim Sturgis; Shawn Jensen; George Tompkins; Lonnie Warren; Jack James; Scott Colling; John Brutlag; Mark Wibben; Steve Miller; Kent Horton
Subject: Fwd: FAA - EWB17573 - Deviation Notification
Attachments: NDL EWB17573.pdf; Cargo Door Handle Housing Assemblies.pdf

Cargo Door Handle Housing Assemblies

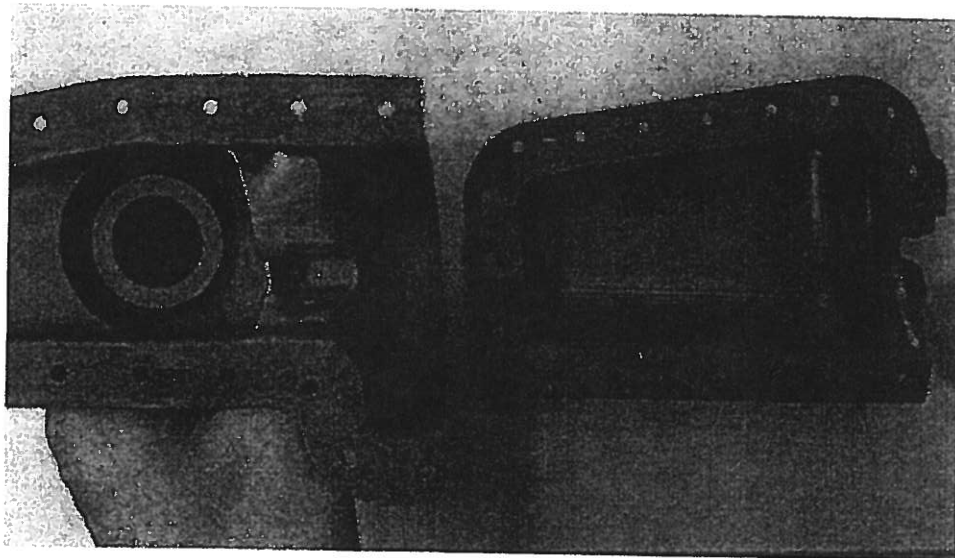
You can determine if you have a new style housing by looking from the outside into the cup where you'd find mill lines from the CNC process if it was indeed a new style housing (Right side).

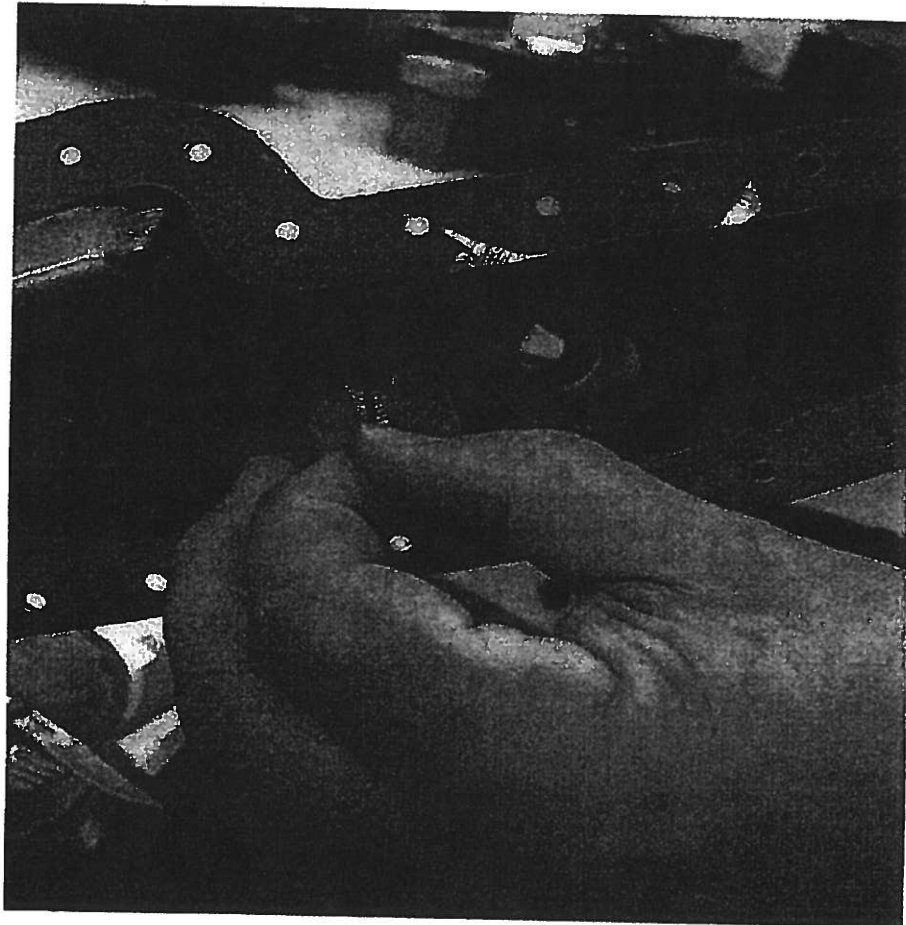
The point of the (picture below) is to demonstrate one method to quickly assess if the housing could possibly be within limits or not (before blending). Also it is important to note that you may find that the housing has already been blended previously causing difficulty in determining remaining thickness.

Example: If you find that you have wear on an old style housing (as shown below) you can use a #53 drill bit that is .0595" and can quickly determine (before blending) if the wear is within limits or not. There are other ways to mechanically measure so you can choose whichever one you find that works best for you. If the housing is blended, it would then require an ultrasonic measurement for confirmation of remaining material thickness and a HFEC after blending.
